**COMPRESSIVE CREEP BEHAVIOR OF NEXTEL™ 720/ALUMINA CERAMIC  
MATRIX COMPOSITE AT 1200°C IN AIR AND IN STEAM ENVIRONMENT**

THESIS

**AIR FORCE INSTITUTE OF TECHNOLOGY**

In Partial Fulfillment of the Requirements for the  
Degree of Master of Science in Aeronautical Engineering

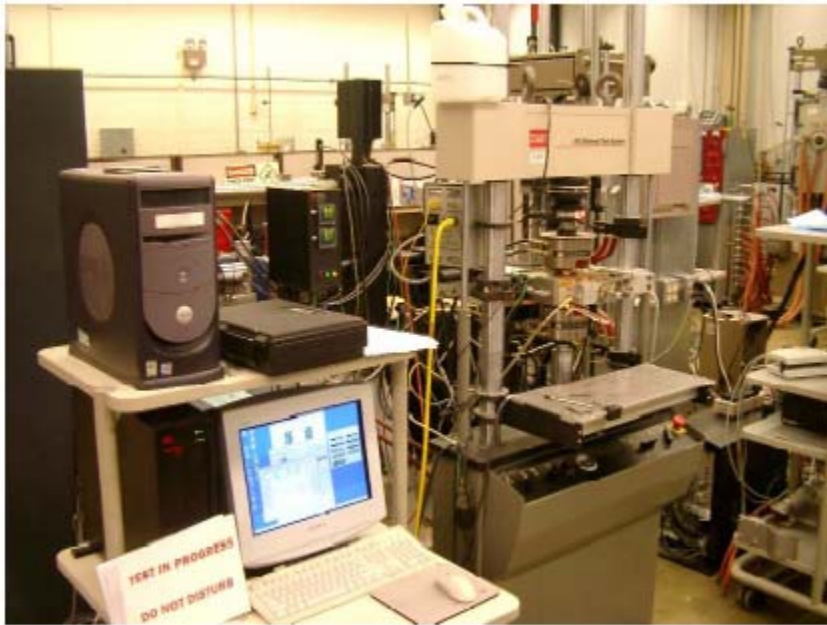
Figure 10. MTS 810 Test Station.

The primary system used in this research was the servo hydraulic machine manufactured by Material Testing Systems (MTS) Corporation. The axial 810 Material

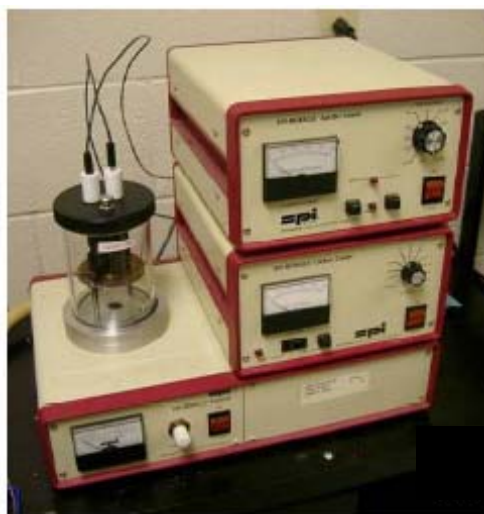
Next, the mounted specimen was placed in a SPI-MODULE Control and Carbon Coater to coat the non-conductive surface of N720/A with a conductive carbon coating. This was achieved by creating a vacuum around the specimen purging it of all air and then sending current through carbon rope, effectively transferring carbon atoms to the fracture surface.

Figure 20. SPI Carbon Coating System.

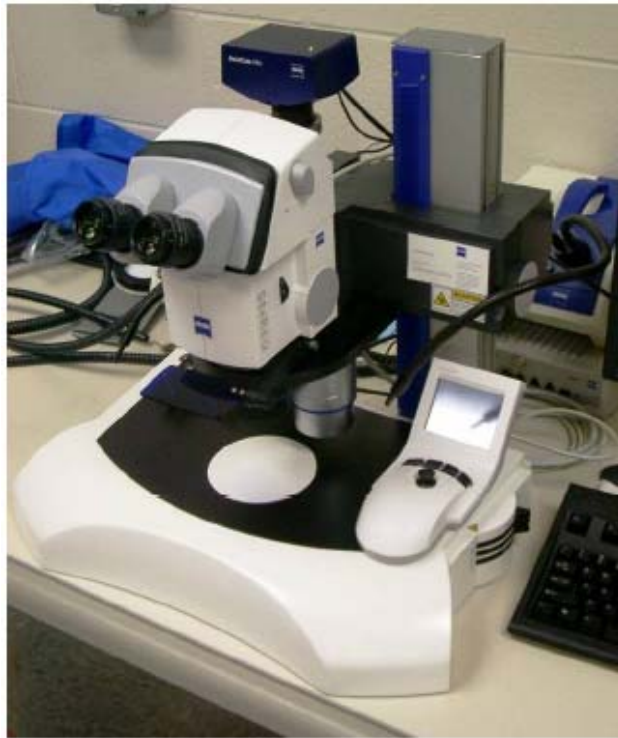
After each test was completed and the specimen achieved failure, the fracture surface was examined using the optical microscope. Typically, each specimen yielded two fracture surfaces and each fracture surface required four photographs to fully document its characteristics. Each fracture surface was different, however, fracture surfaces of specimens which were exposed to similar environments and loadings histories showed significant resemblance.

Figure 21. Zeiss Optical Microscope.

A simple procedure was used to capture clear and detailed optical micrographs. The procedure included five steps. (1) The procedure involved selecting appropriate lighting at the 3200K setting so as to not overexpose areas of the specimen. (2) A z-stack function was performed to capture images at different depth levels throughout the specimen. (3) The z-stack images were then overlaid using a geometric alignment function to create a three dimensional picture. (4) In order to adjust the z-stack images on top of one another an extended focus was performed to perfectly align and focus each level of the image. (5) Finally, the image was sharpened to define individual fibers and matrix cracking and then smoothed in a gauss format to provide the optimal micrograph.

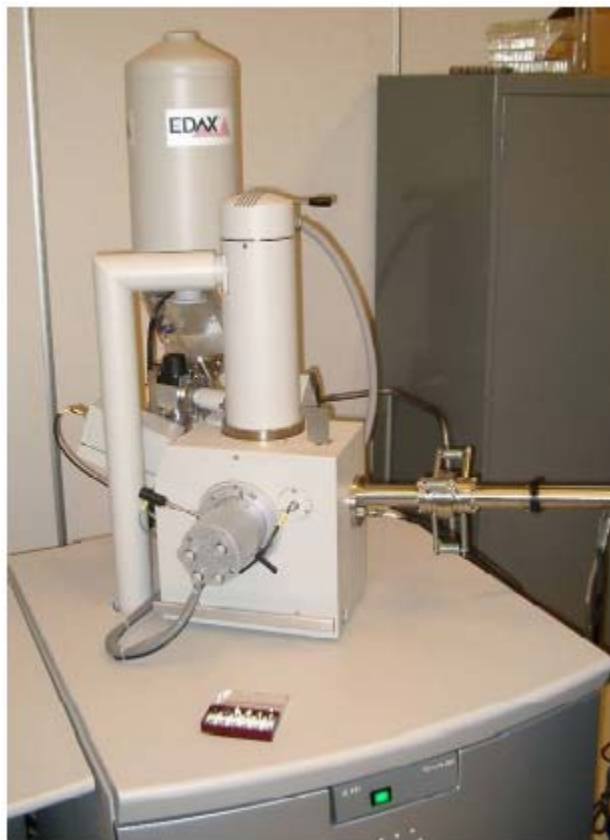
Figure 22. FEI Quanta Scanning Electron Microscope (SEM) and EDAX X-Ray Analysis System.

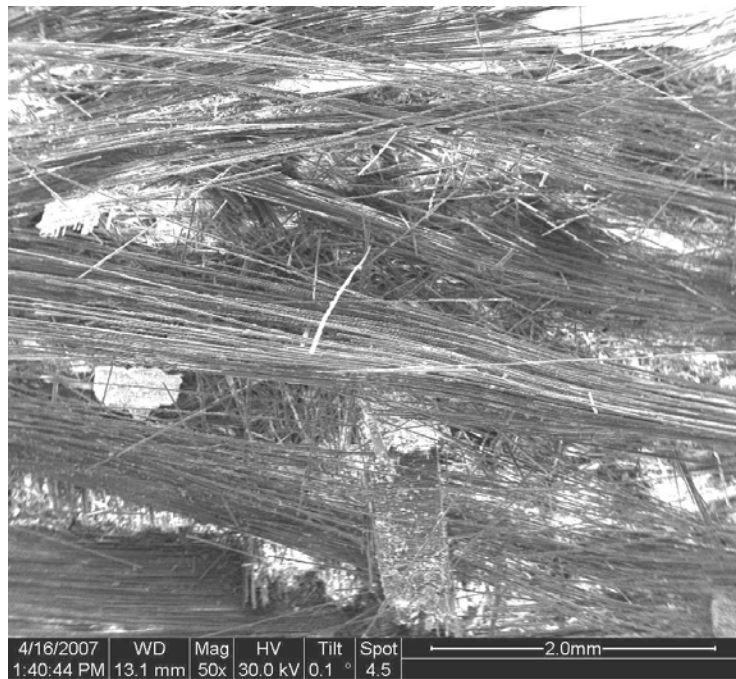
Figure 53. Fracture surface of N720/A specimen tested in compression to failure in displacement control at a rate of -0.05 mm/s in steam at 1200°C.

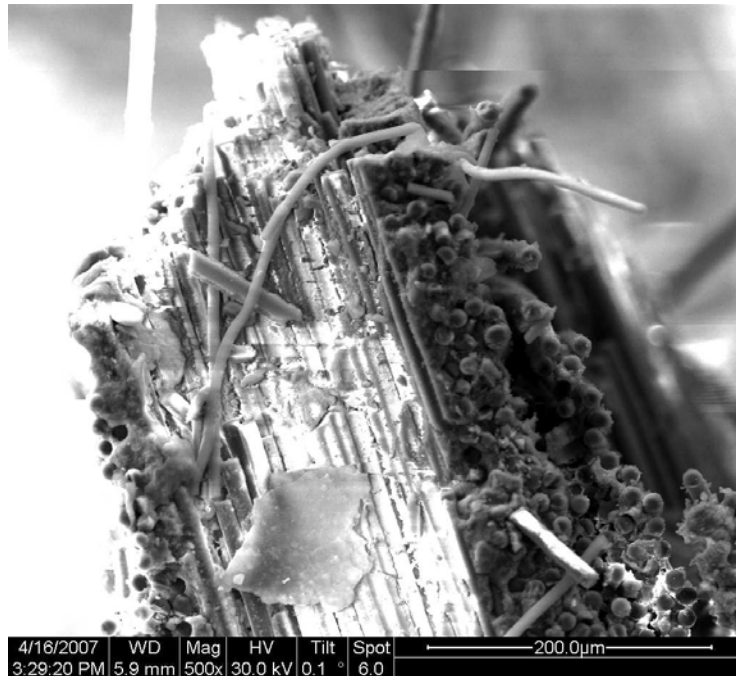
Figure 74. Fracture surface of N720/A specimen tested in compression to failure in displacement control at a rate of -0.05 mm/s in steam at 1200°C.

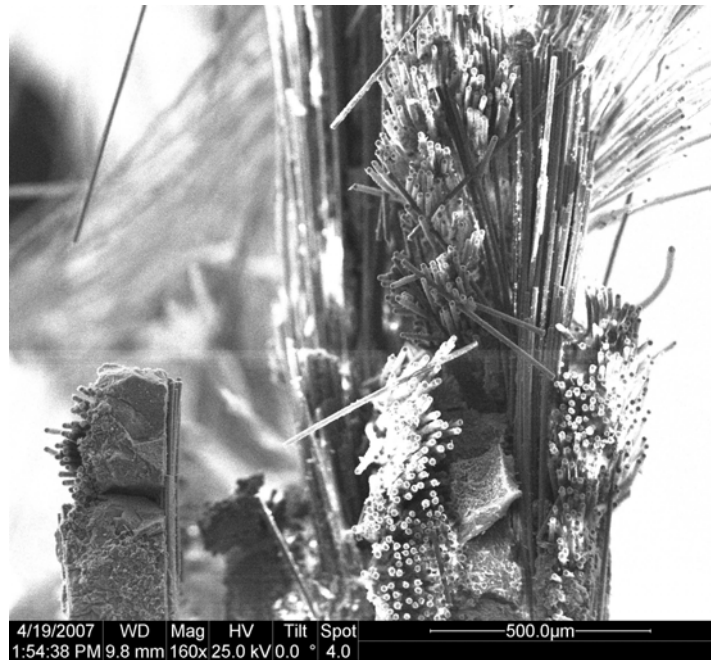
Figure 94. Fracture surface of N720/A specimen tested in creep at 60 MPa in air at 1200°C.

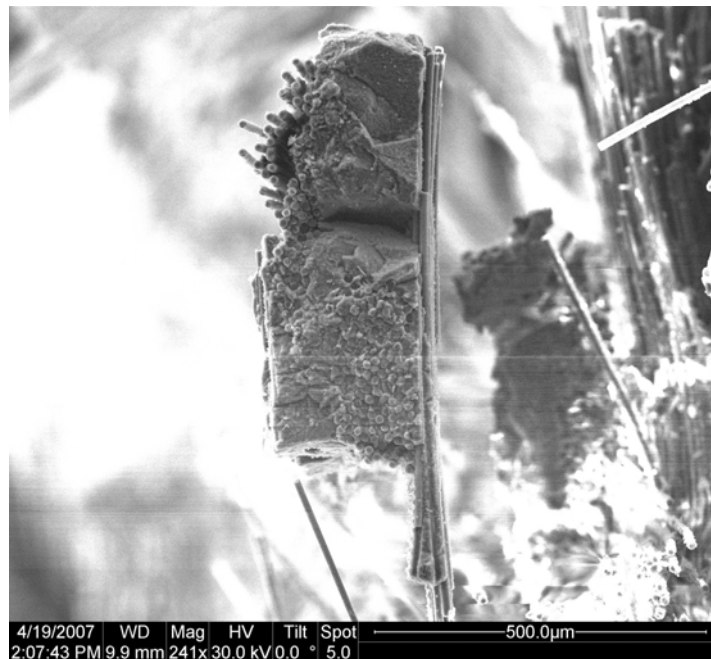
Figure 99. Fracture surface of N720/A specimen tested in creep at 60 MPa in air at 1200°C.

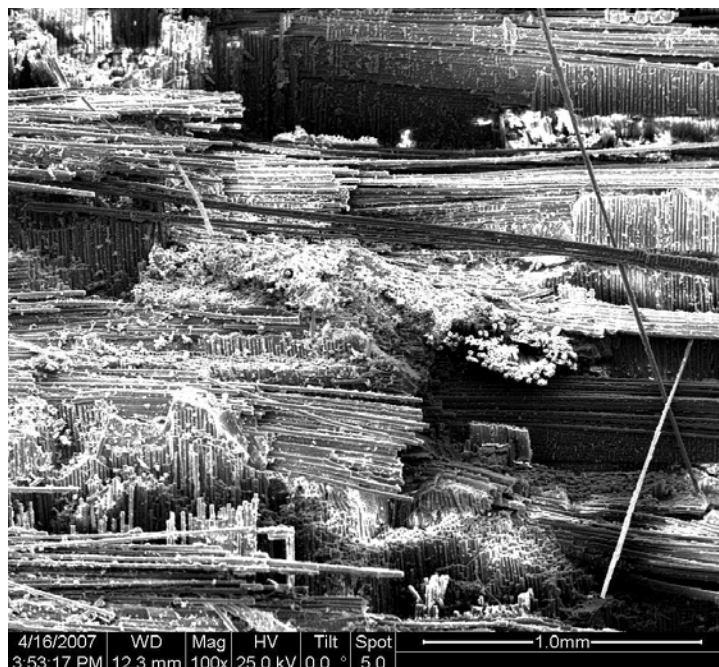
Figure 103. Fracture surface of N720/A specimen tested in creep at 60 MPa in steam at 1200°C.

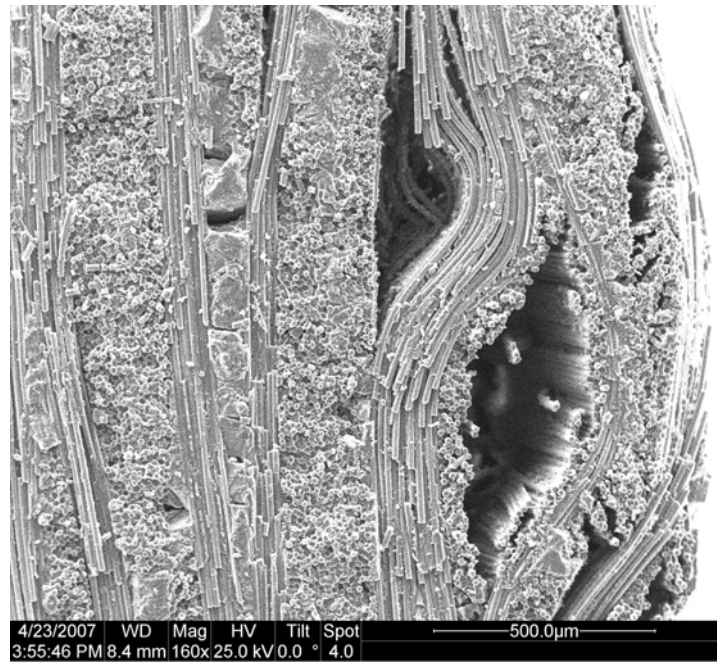
Figure 162. Fracture surface of N720/A specimen tested in compression to failure in load control at a rate of -0.0025 MPa/s in steam at 1200°C.

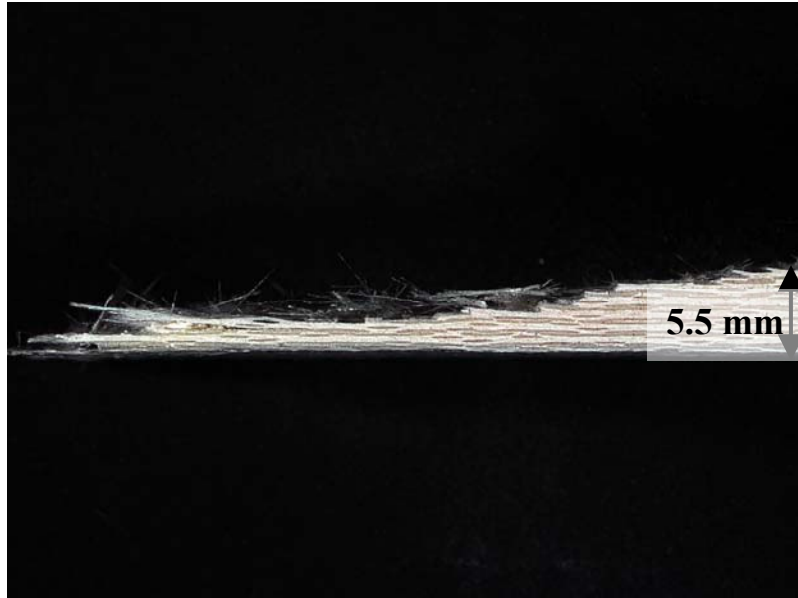
Figure 169. Fracture surface of N720/A specimen tested in compression to failure in displacement control at a rate of -0.05 mm/s in air at 1200°C.

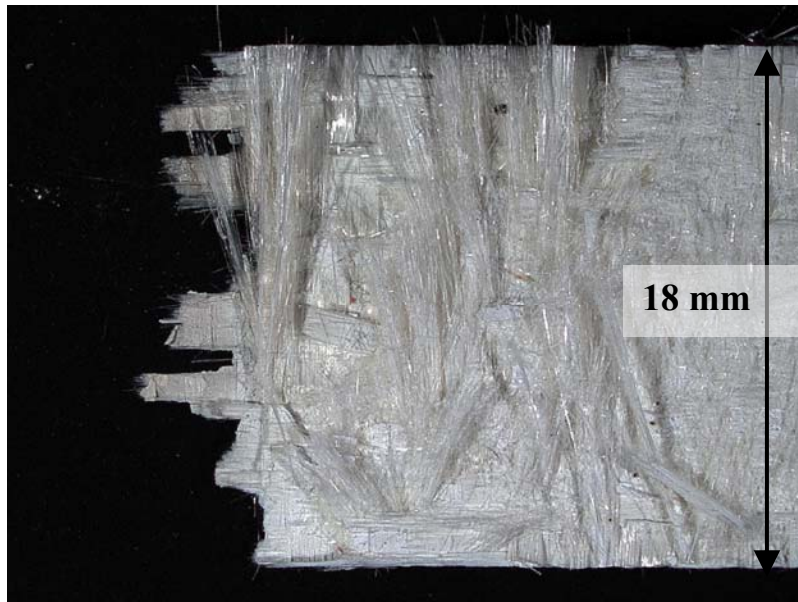
Figure 170. Fracture surface of N720/A specimen tested in compression to failure in displacement control at a rate of -0.05 mm/s in air at 1200°C.

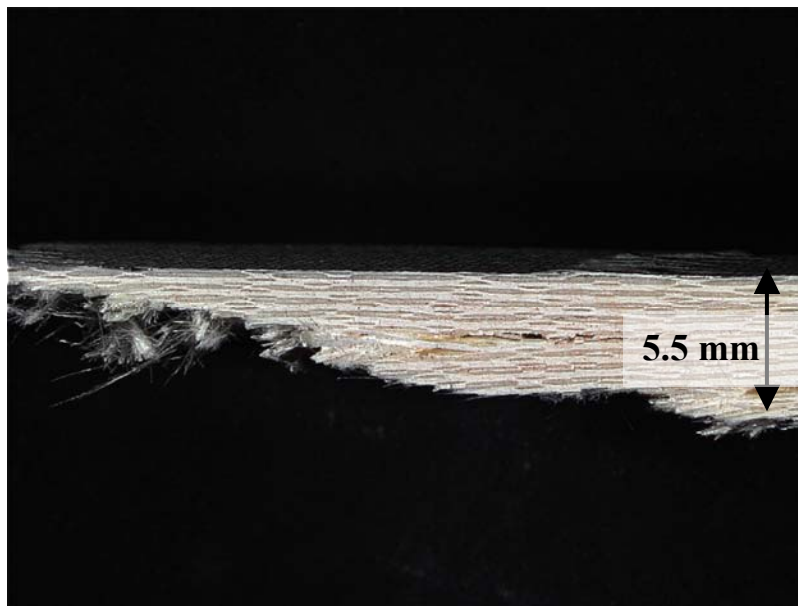
Figure 174. Fracture surface of N720/A specimen tested in compression to failure in displacement control at a rate of -0.05 mm/s in air at 1200°C.

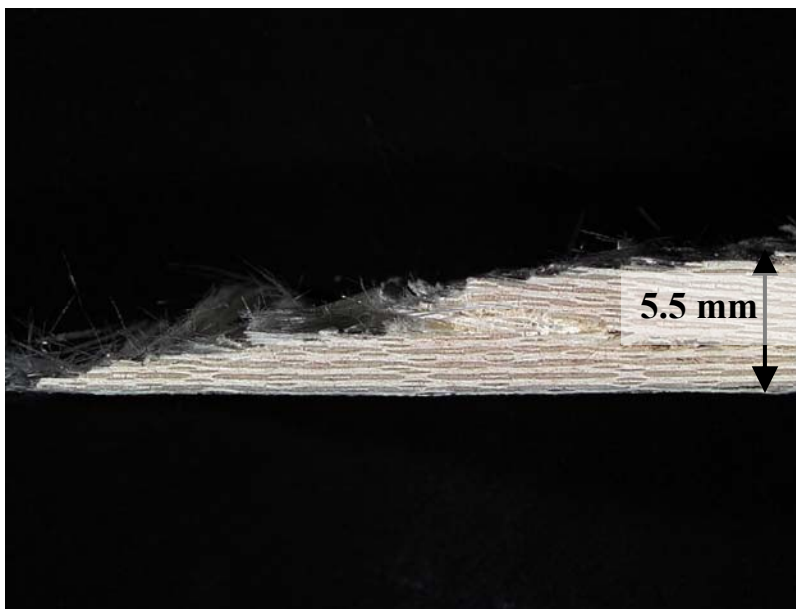
Figure 175. Fracture surface of N720/A specimen tested in compression to failure in displacement control at a rate of -0.05 mm/s in air at 1200°C.

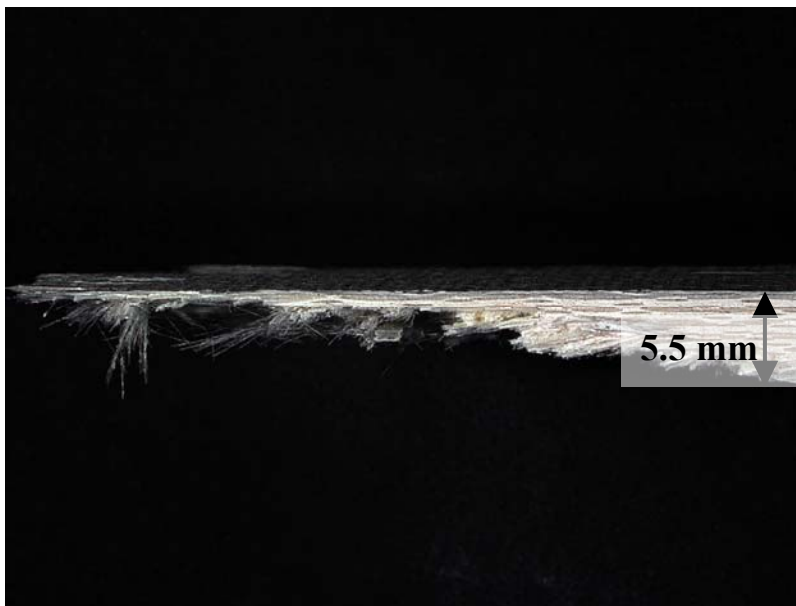
Figure 176. Fracture surface of N720/A specimen tested in compression to failure in displacement control at a rate of -0.05 mm/s in air at 1200°C.

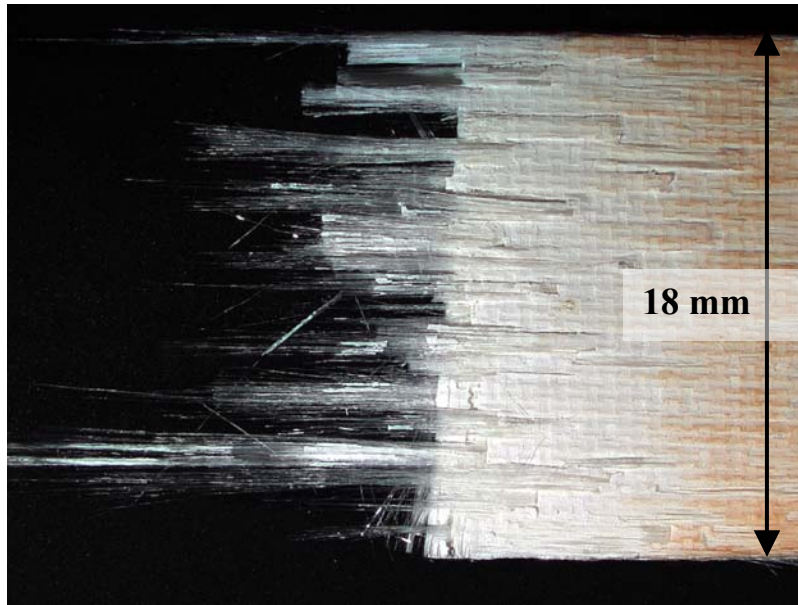
Figure 177. Fracture surface of N720/A specimen tested in compressive creep at -100 MPa for 100 h at 1200°C in air.

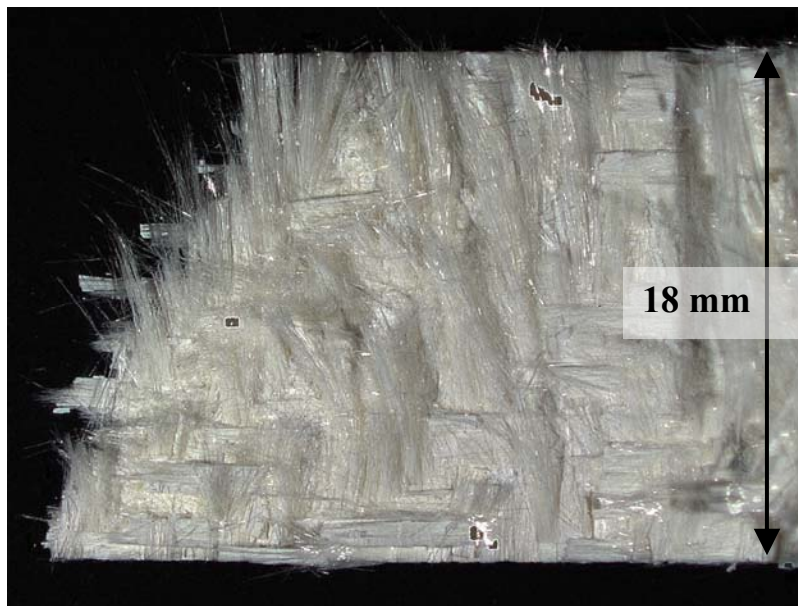
Figure 178. Fracture surface of N720/A specimen tested in compressive creep at -100 MPa for 100 h at 1200°C in air.

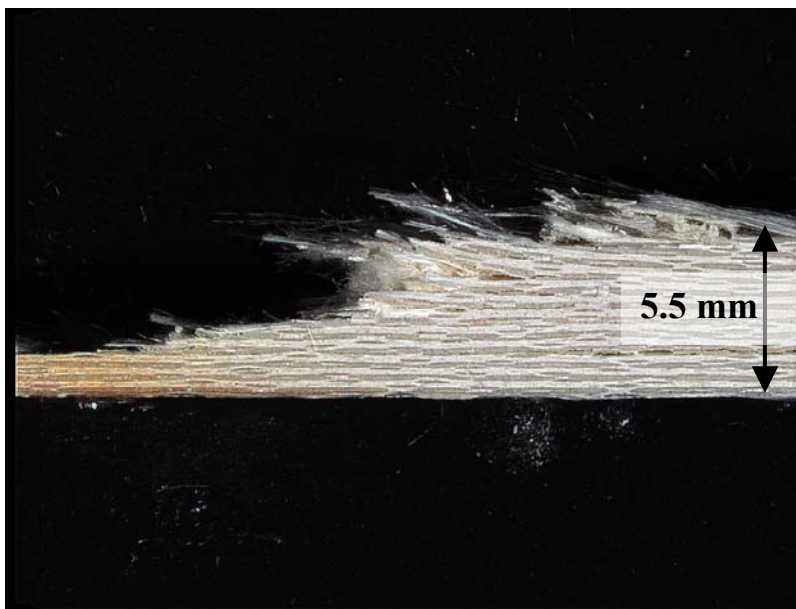
Figure 181. Fracture surface of N720/A specimen tested in compressive creep at -100 MPa for 100 h at 1200°C in air.

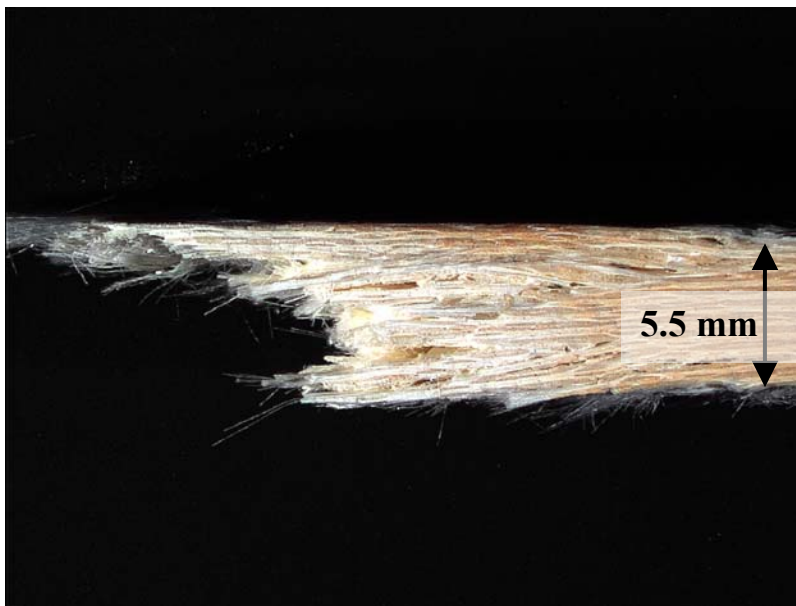
Figure 182. Fracture surface of N720/A specimen tested in compressive creep at -100 MPa for 100 h at 1200°C in air.

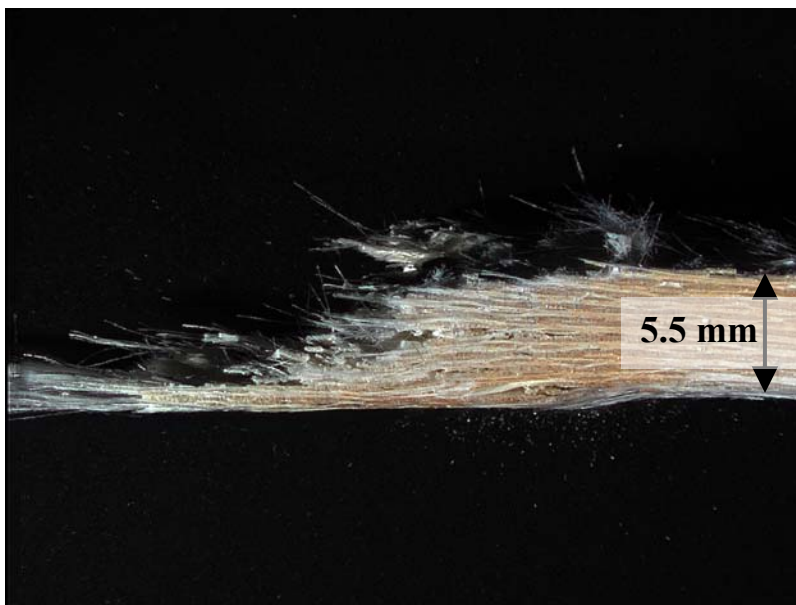
Figure 183. Fracture surface of N720/A specimen tested in compressive creep at -100 MPa for 100 h at 1200°C in air.

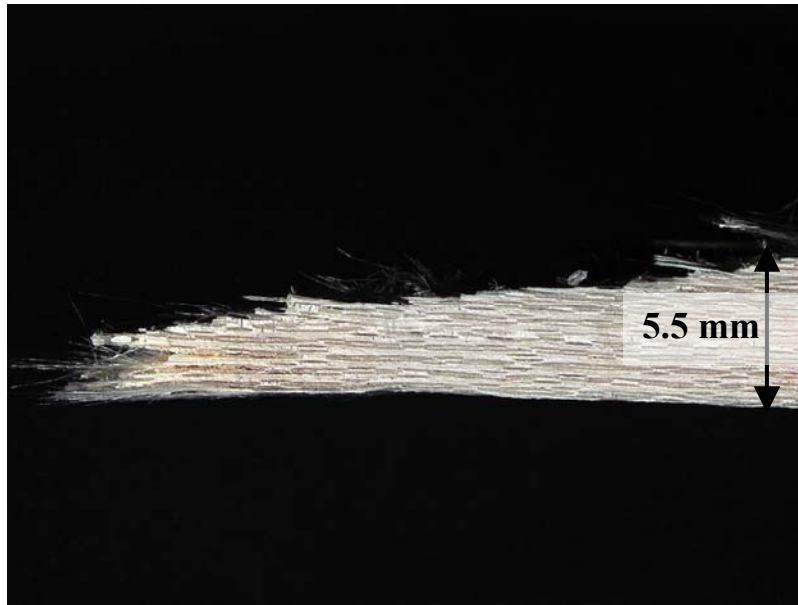
Figure 185. Fracture surface of N720/A specimen tested in compressive creep at -60 MPa for 100 h at 1200°C in air.

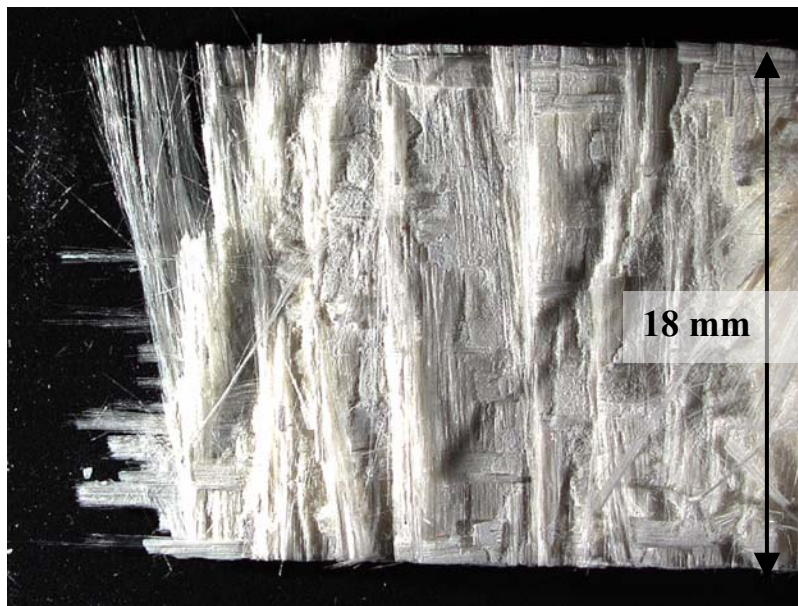
Figure 186. Fracture surface of N720/A specimen tested in compressive creep at -60 MPa for 100 h at 1200°C in air.

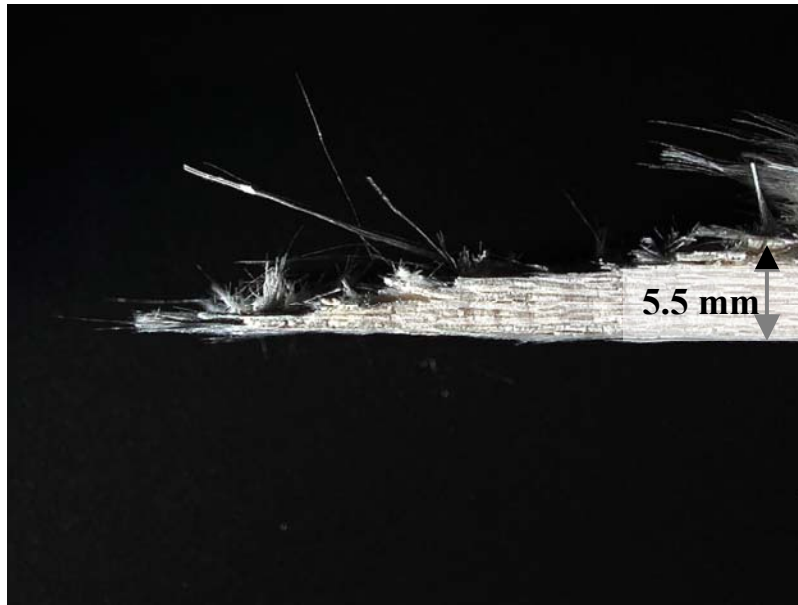
Figure 189. Fracture surface of N720/A specimen tested in compressive creep at -60 MPa for 100 h at 1200°C in air.

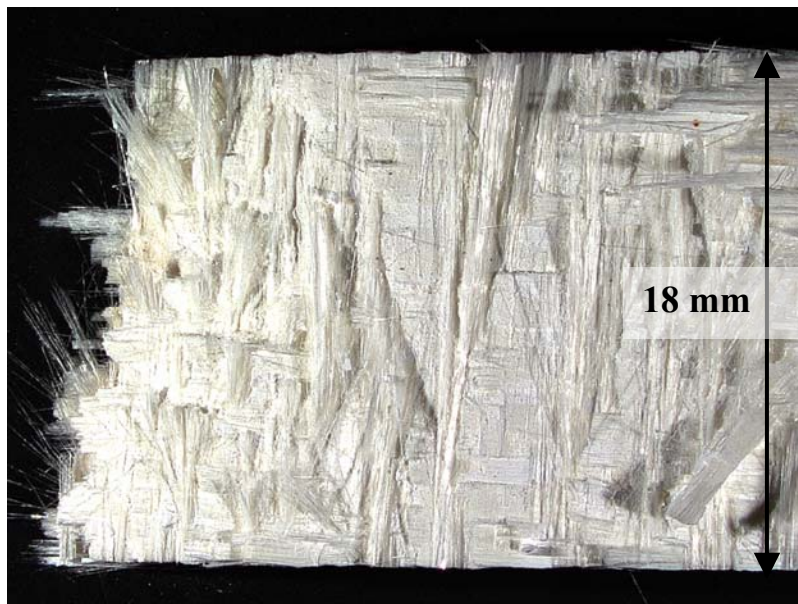
Figure 190. Fracture surface of N720/A specimen tested in compressive creep at -60 MPa for 100 h at 1200°C in air.

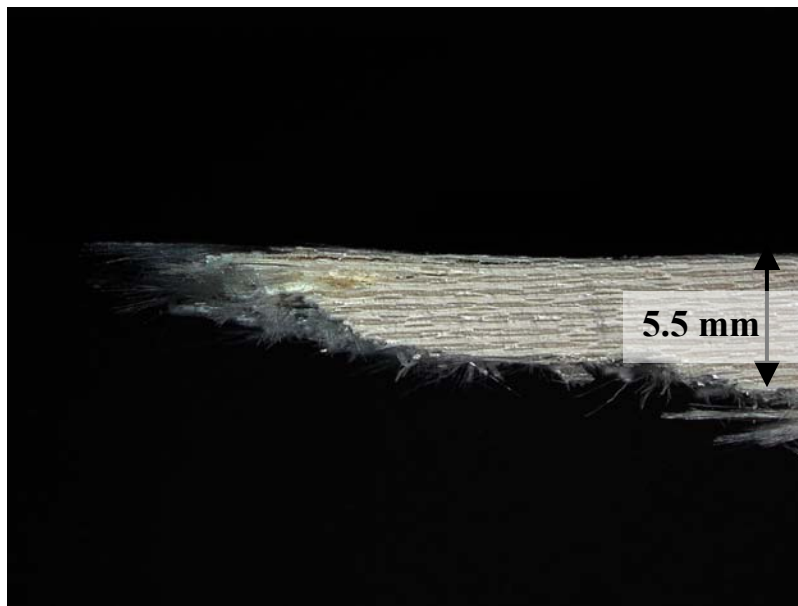
Figure 192. Fracture surface of N720/A specimen tested in compressive creep at -60 MPa for 100 h at 1200°C in air.

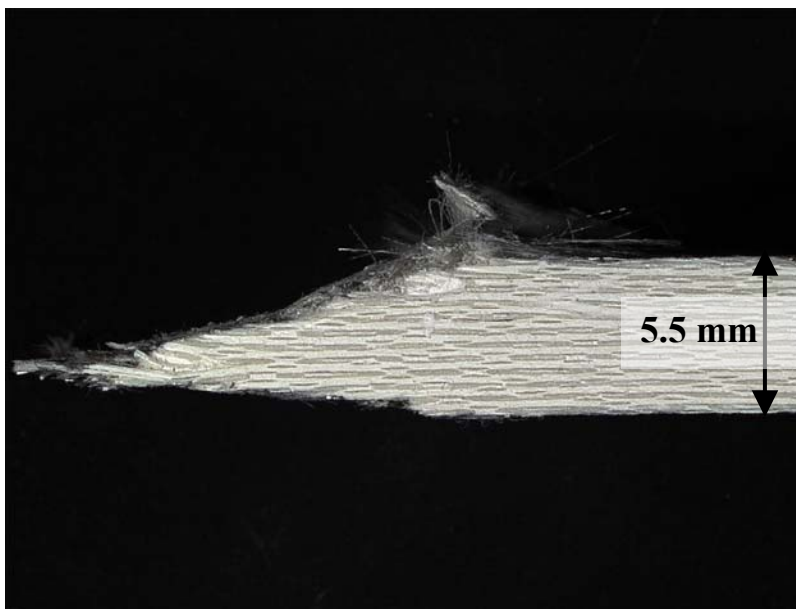
Figure 193. Fracture surface of N720/A specimen tested in compressive creep at -100 MPa for 100 h at 1200°C in steam.

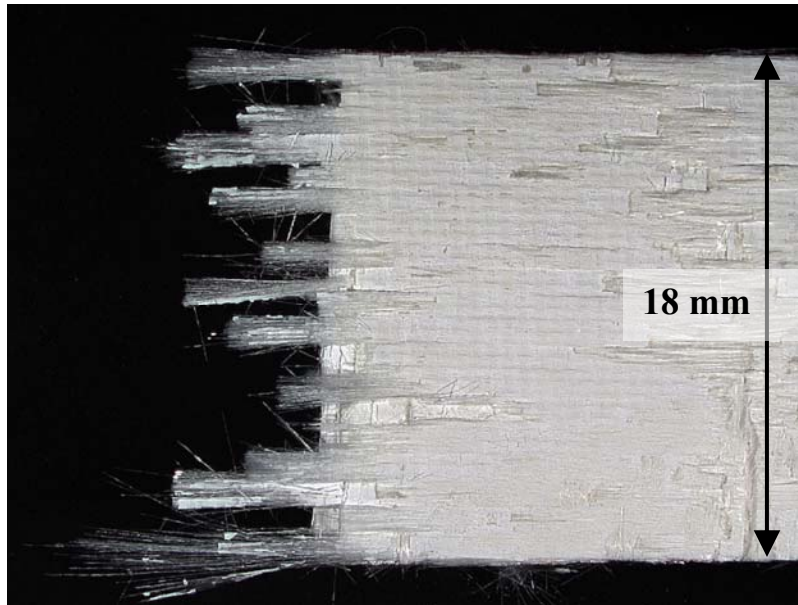
Figure 195. Fracture surface of N720/A specimen tested in compressive creep at -100 MPa for 100 h at 1200°C in steam.

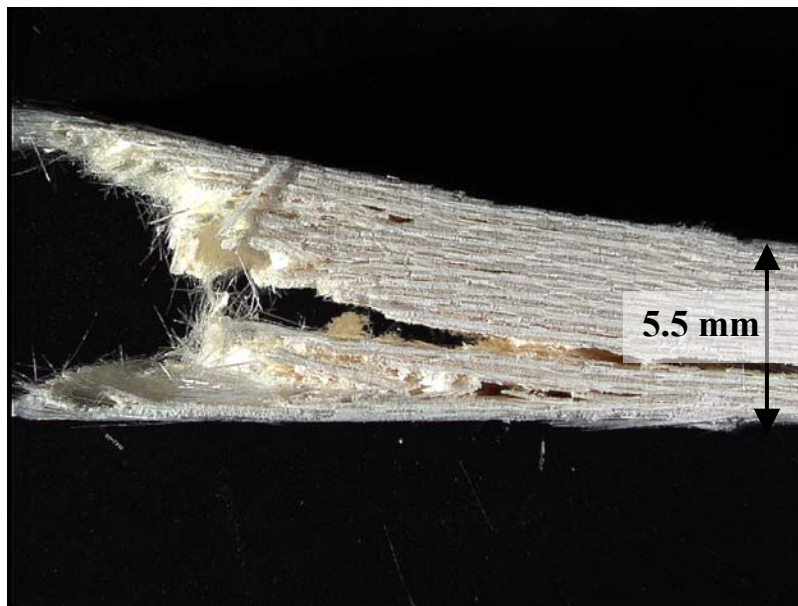
Figure 196. Fracture surface of N720/A specimen tested in compressive creep at -100 MPa for 100 h at 1200°C in steam.

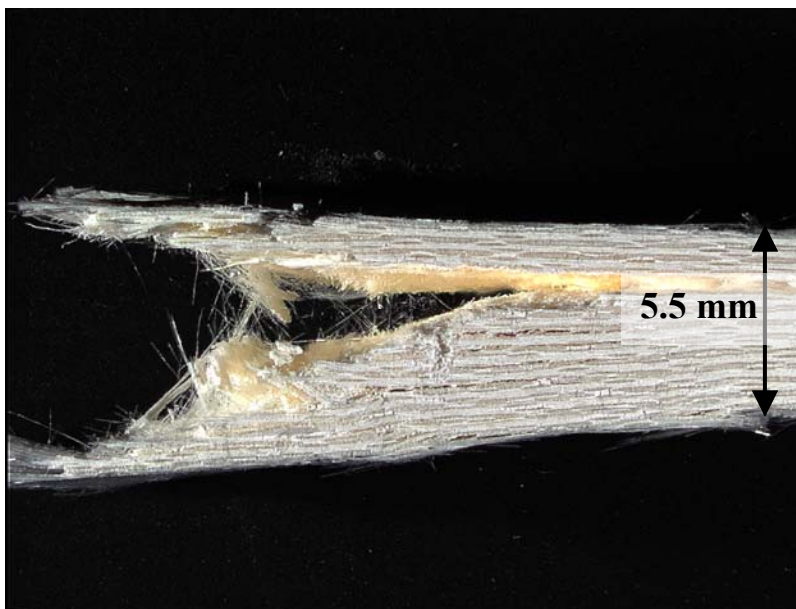
Figure 197. Fracture surface of N720/A specimen tested in compressive creep at -100 MPa for 100 h at 1200°C in steam.

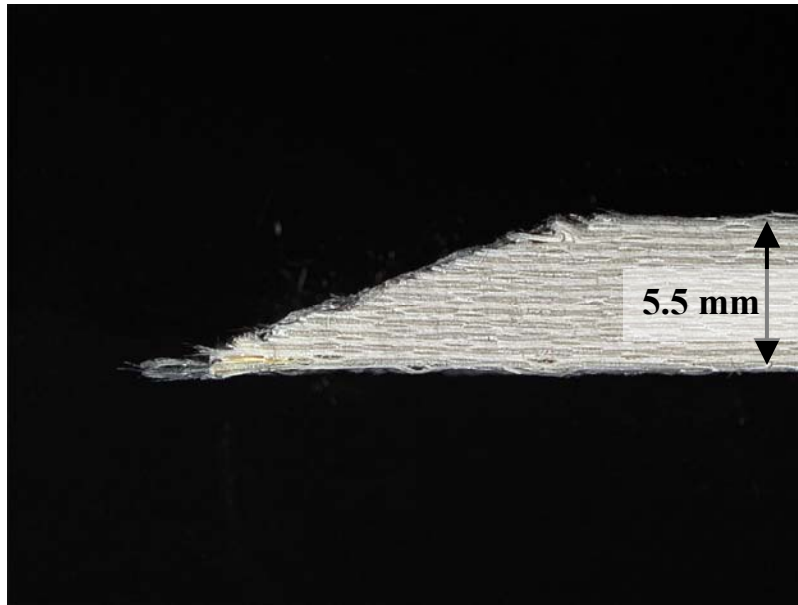
Figure 199. Fracture surface of N720/A specimen tested in compressive creep at -60 MPa for 100 h at 1200°C in steam.

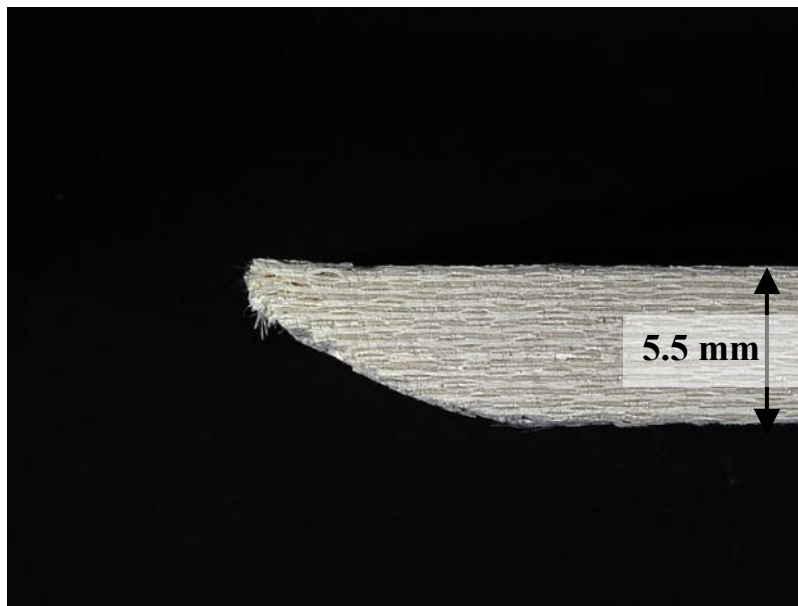
Figure 202. Fracture surface of N720/A specimen tested in compressive creep at -60 MPa for 100 h at 1200°C in steam.

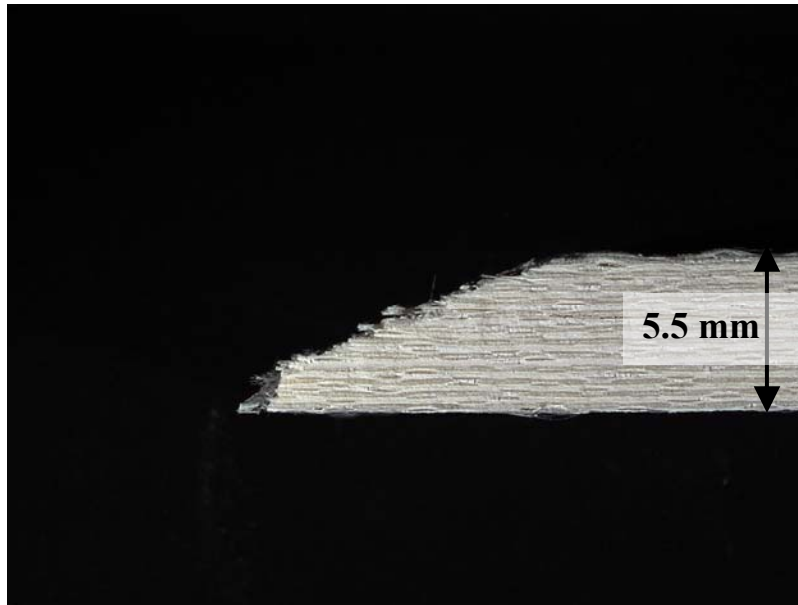
Figure 203. Fracture surface of N720/A specimen tested in compressive creep at -60 MPa for 100 h at 1200°C in steam.

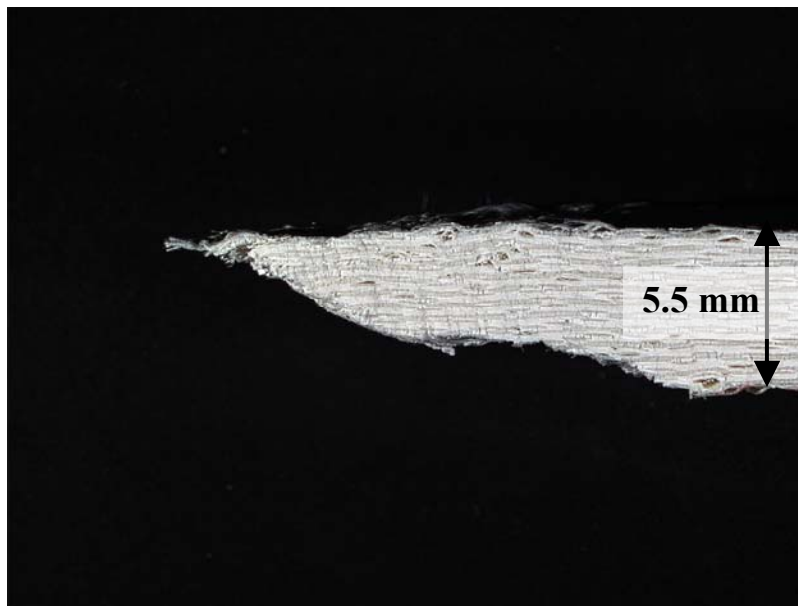
Figure 210. Fracture surface of N720/A specimen tested in compressive creep at -40 MPa for 100 h at 1200°C in steam.

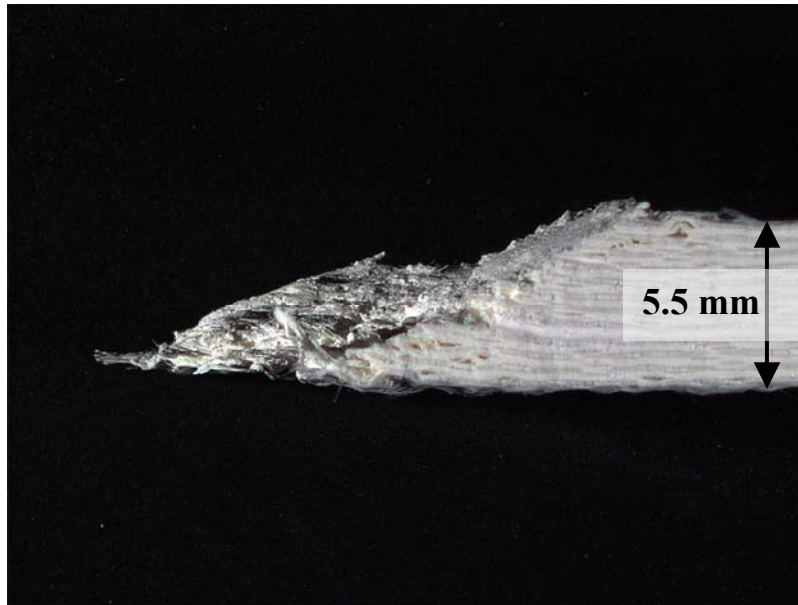
Figure 211. Fracture surface of N720/A specimen tested in compressive creep at -40 MPa for 100 h at 1200°C in steam.

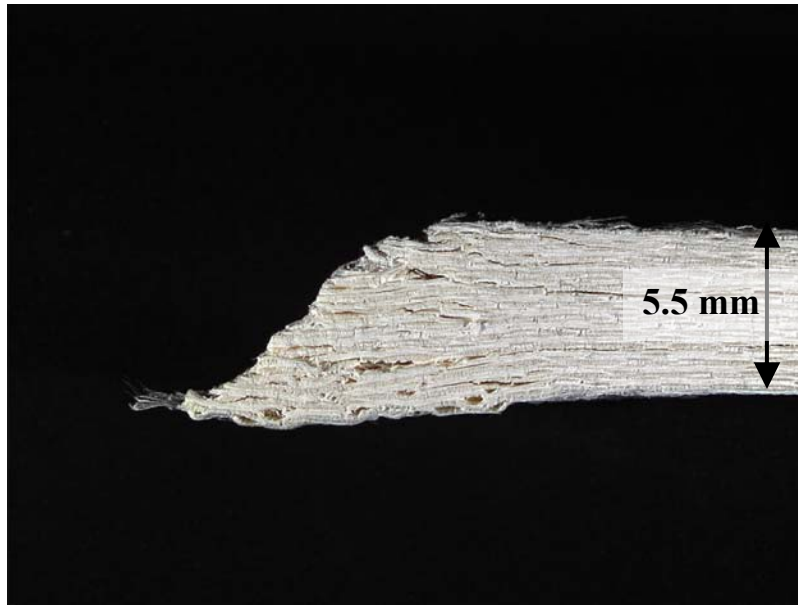
Figure 213. Fracture surface of N720/A specimen tested in compressive creep at -40 MPa for 100 h at 1200°C in steam.

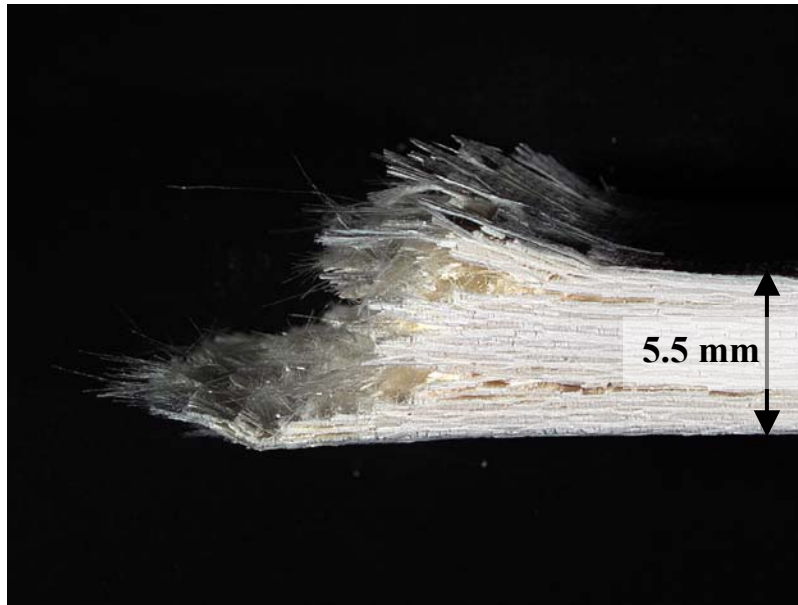
Figure 215. Fracture surface of N720/A specimen subjected to aging in steam at 1200°C for 25 h then failed in compression.

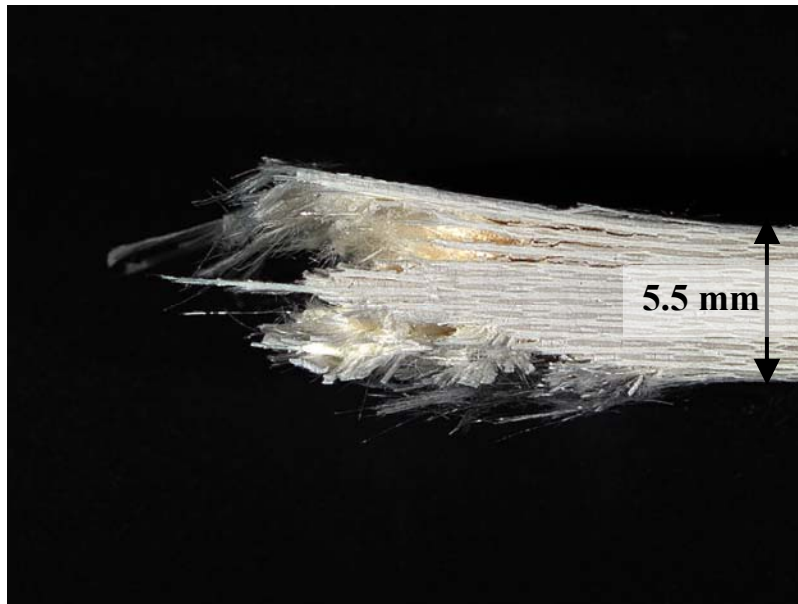
Figure 218. Fracture surface of N720/A specimen subjected to aging in steam at 1200°C for 25 h then failed in compression.

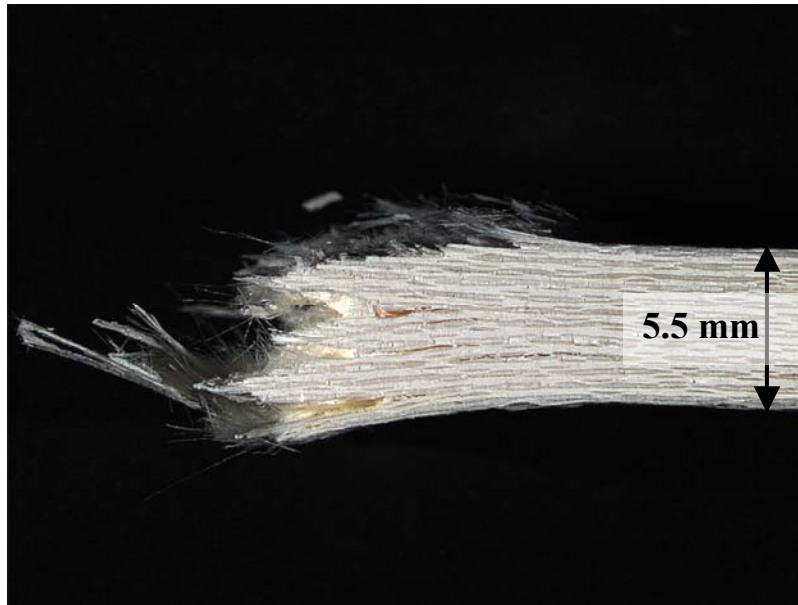
Figure 219. Fracture surface of N720/A specimen subjected to aging in steam at 1200°C for 25 h then failed in compression.

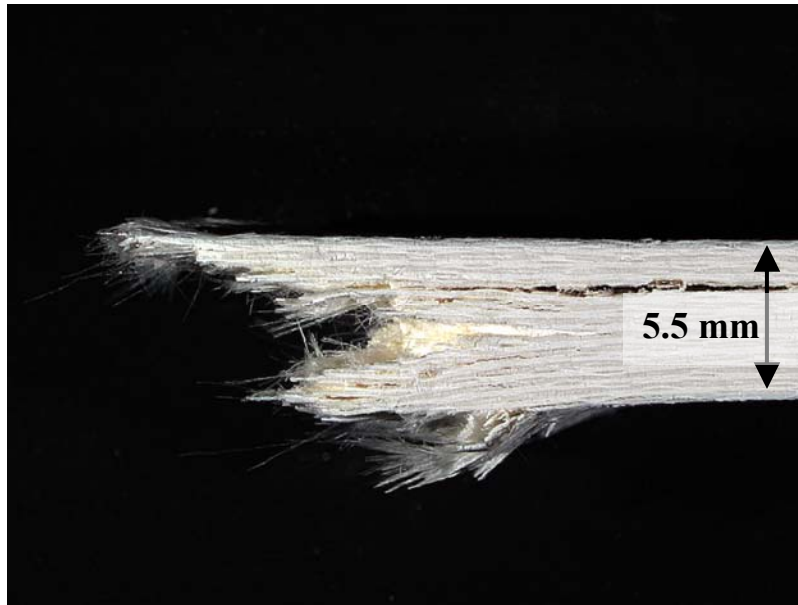
Figure 221. Fracture surface of N720/A specimen subjected to aging in steam at 1200°C for 25 h then failed in compression.

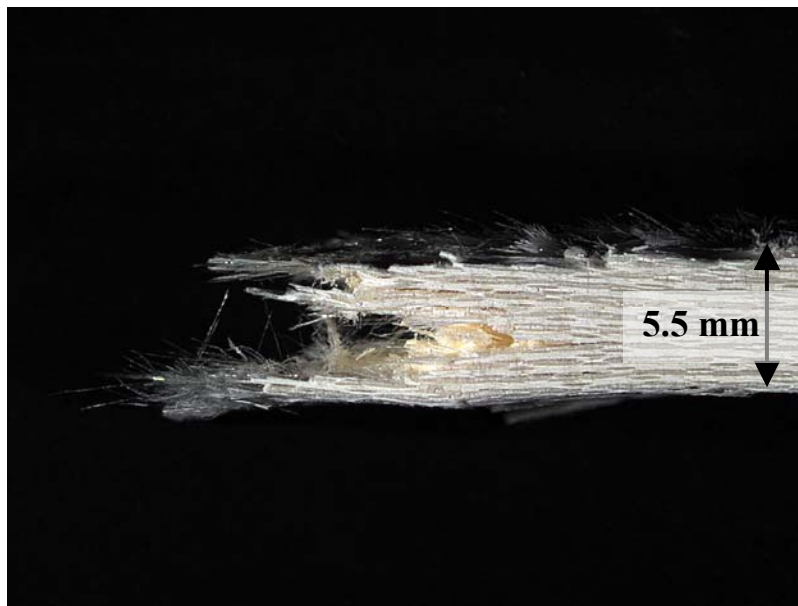
Figure 222. Fracture surface of N720/A specimen tested in compression to failure in steam at 1200°C in displacement control at -0.05 mm/s.

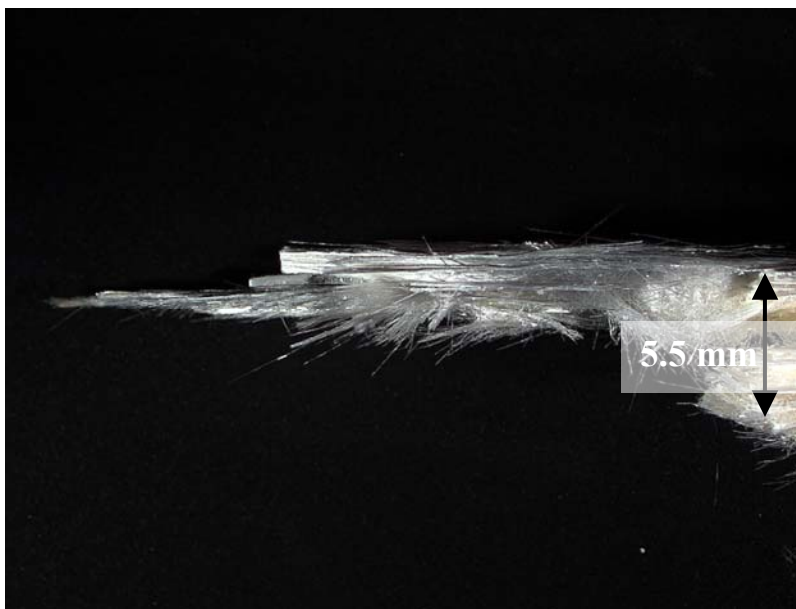
Figure 225. Fracture surface of N720/A specimen tested in compression to failure in steam at 1200°C in displacement control at -0.05 mm/s.

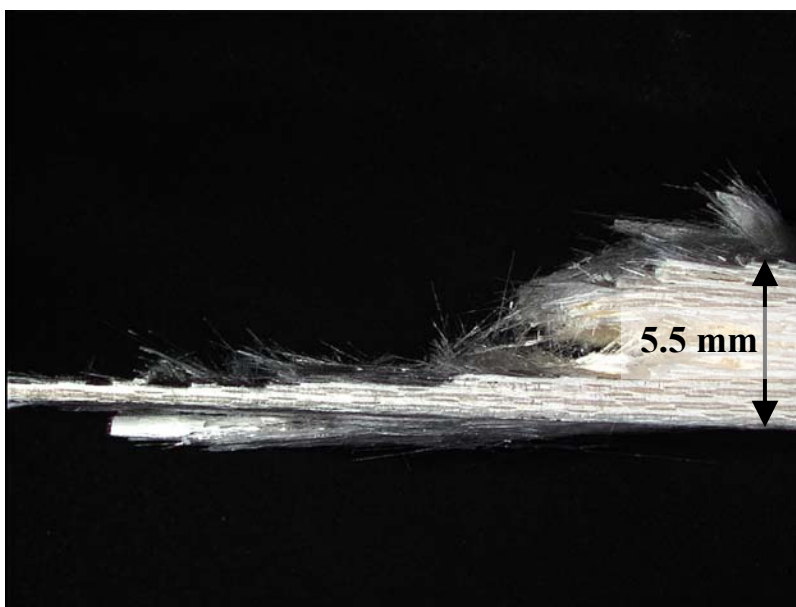
Figure 226. Fracture surface of N720/A specimen tested in compression to failure in steam at 1200°C in displacement control at -0.05 mm/s.

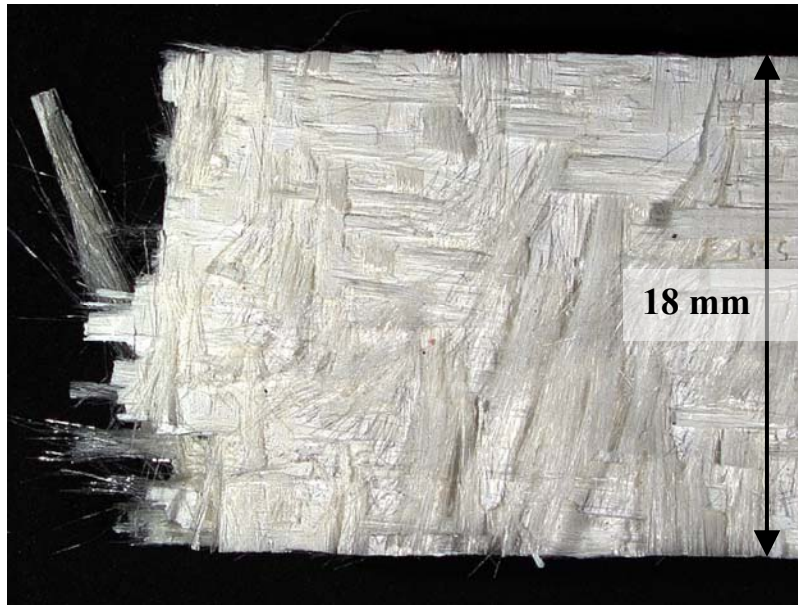
Figure 227. Fracture surface of N720/A specimen tested in compression to failure in steam at 1200°C in displacement control at -0.05 mm/s.

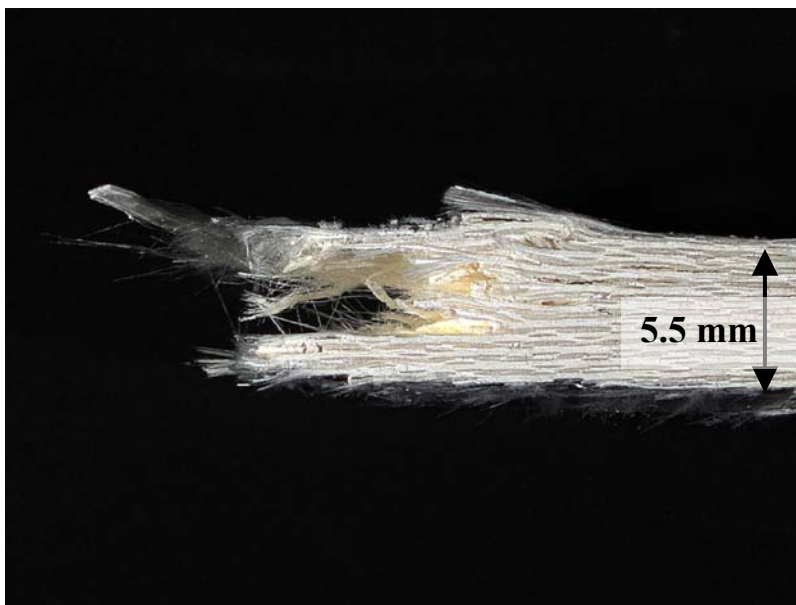
Figure 229. Fracture surface of N720/A specimen tested in compression to failure in steam at 1200°C in displacement control at -0.05 mm/s.
